TECHNICAL REPORT H-77-22

BREAKWATER STABILITY STUDY IMPERIAL BEACH, CALIFORNIA

Hydraulic Model Investigation

Prepared for U. S. Army Engineer District, Los Angeles
Los Angeles, California 90053

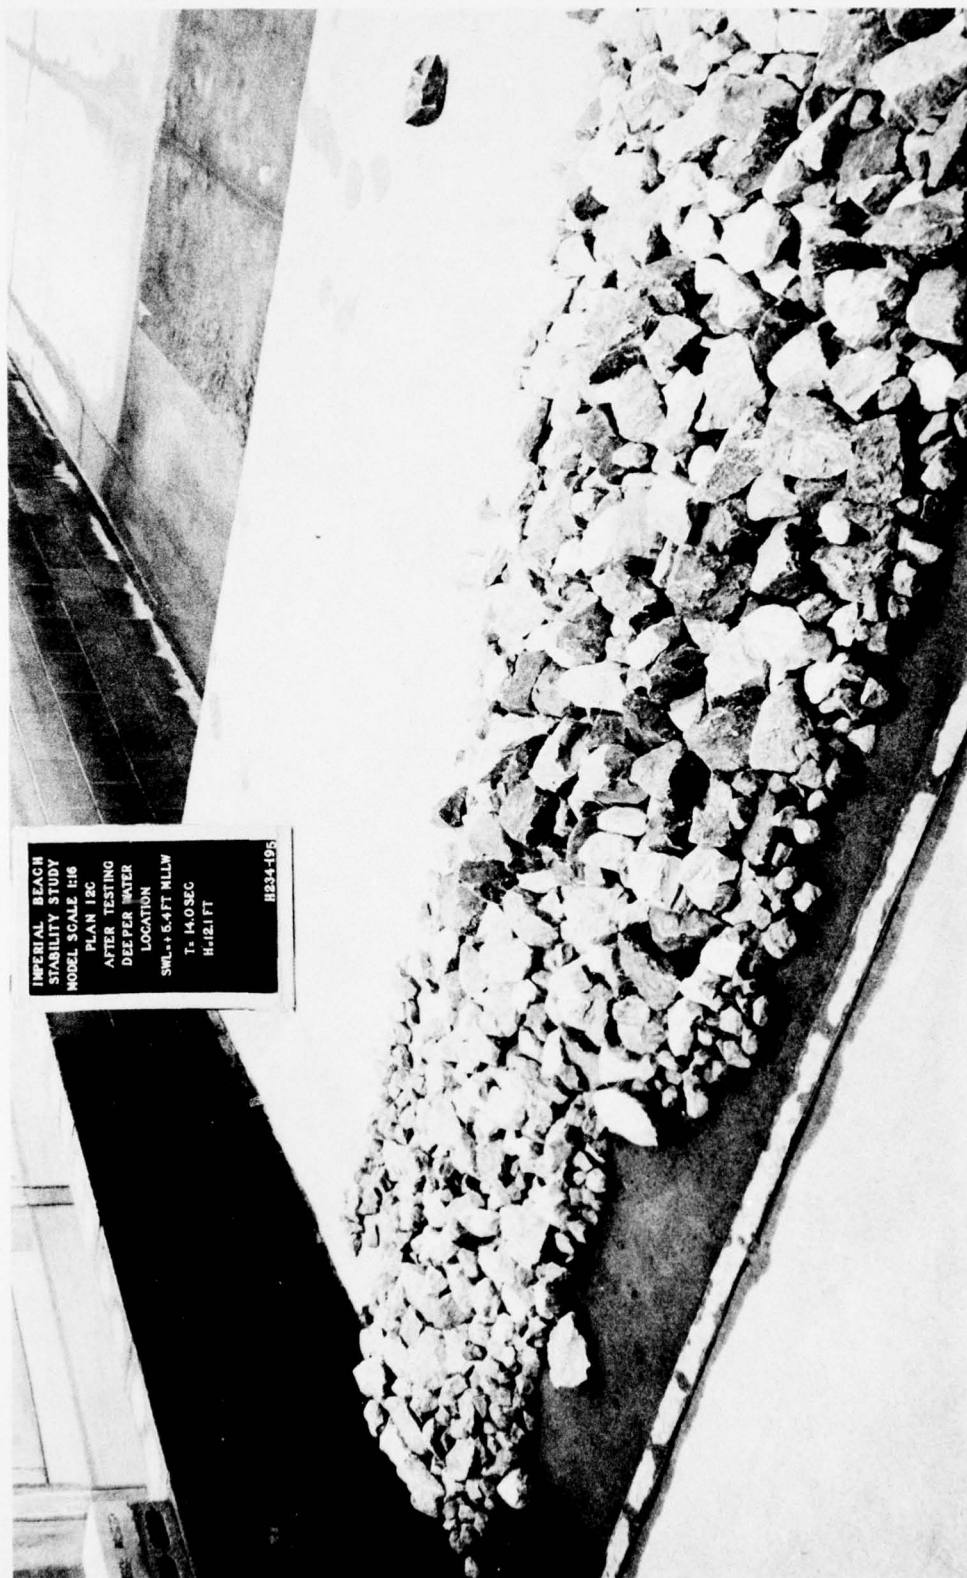
Photo 78. Sea-side view of low-sill section of Plan 12C in the deeper water location after 10.0 hr of 14.0-sec, 12.1-ft waves at an swl of +5.4 ft mllw

of +5.4 ft mllw since its initial building and had sustained minor to moderate damage (Photos 76-78).

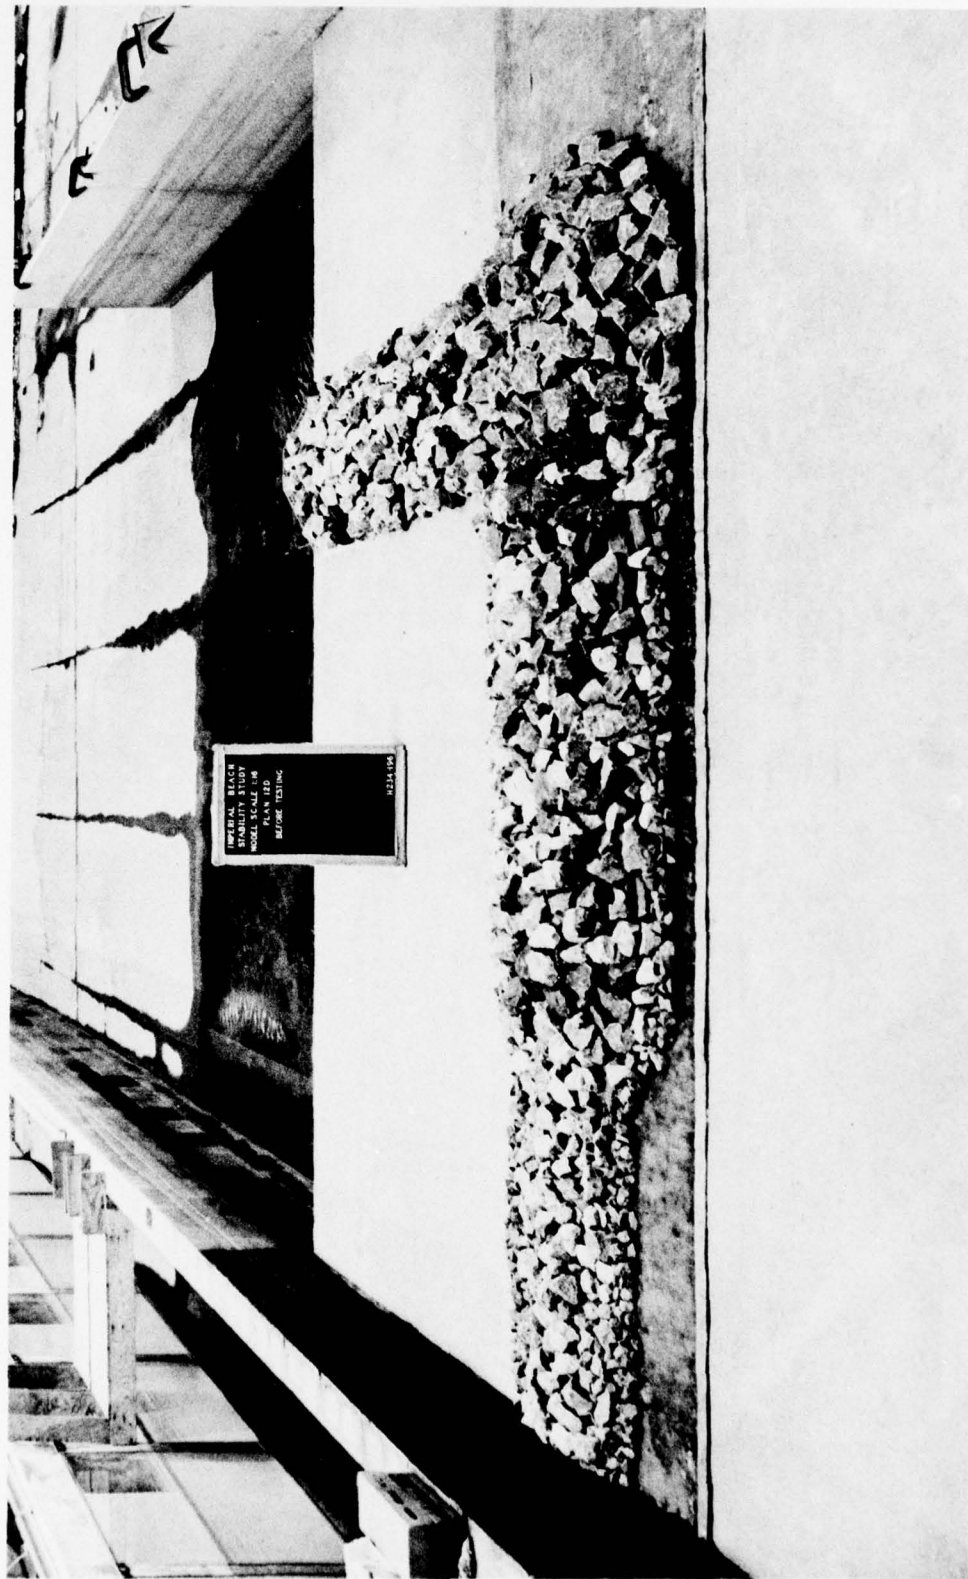
Photo 79. Sea-side view of Plan 12D before wave attack

32. Plan 12D (Plate 21 and Photo 79) consisted of rebuilding a breakwater identical with Plan 12B except that 7.0-ton graded armor stone was used in the 10-ft-high groin instead of 5.0-ton graded armor stone. This plan was tested to determine if larger graded armor stone could be used as an alternative to capping the first 40 ft of the groin with 7.0-ton armor stone as was done in Plan 12C. After 2.0 hr of exposure to 14.0-sec, 12.1-ft waves at an swl of +5.4 ft mllw, the high-sill and low-sill trunk had accrued minor damage. The high-sill head had sustained moderate damage, very similar to previous test results. The connecting area between the high-sill head and the 10-ft-high groin showed moderate damage at the conclusion of the test (Photos 80-82). Damage in this area was somewhat less than that of Plan 12B but more than that sustained by Plan 12C when exposed to the identical test conditions.

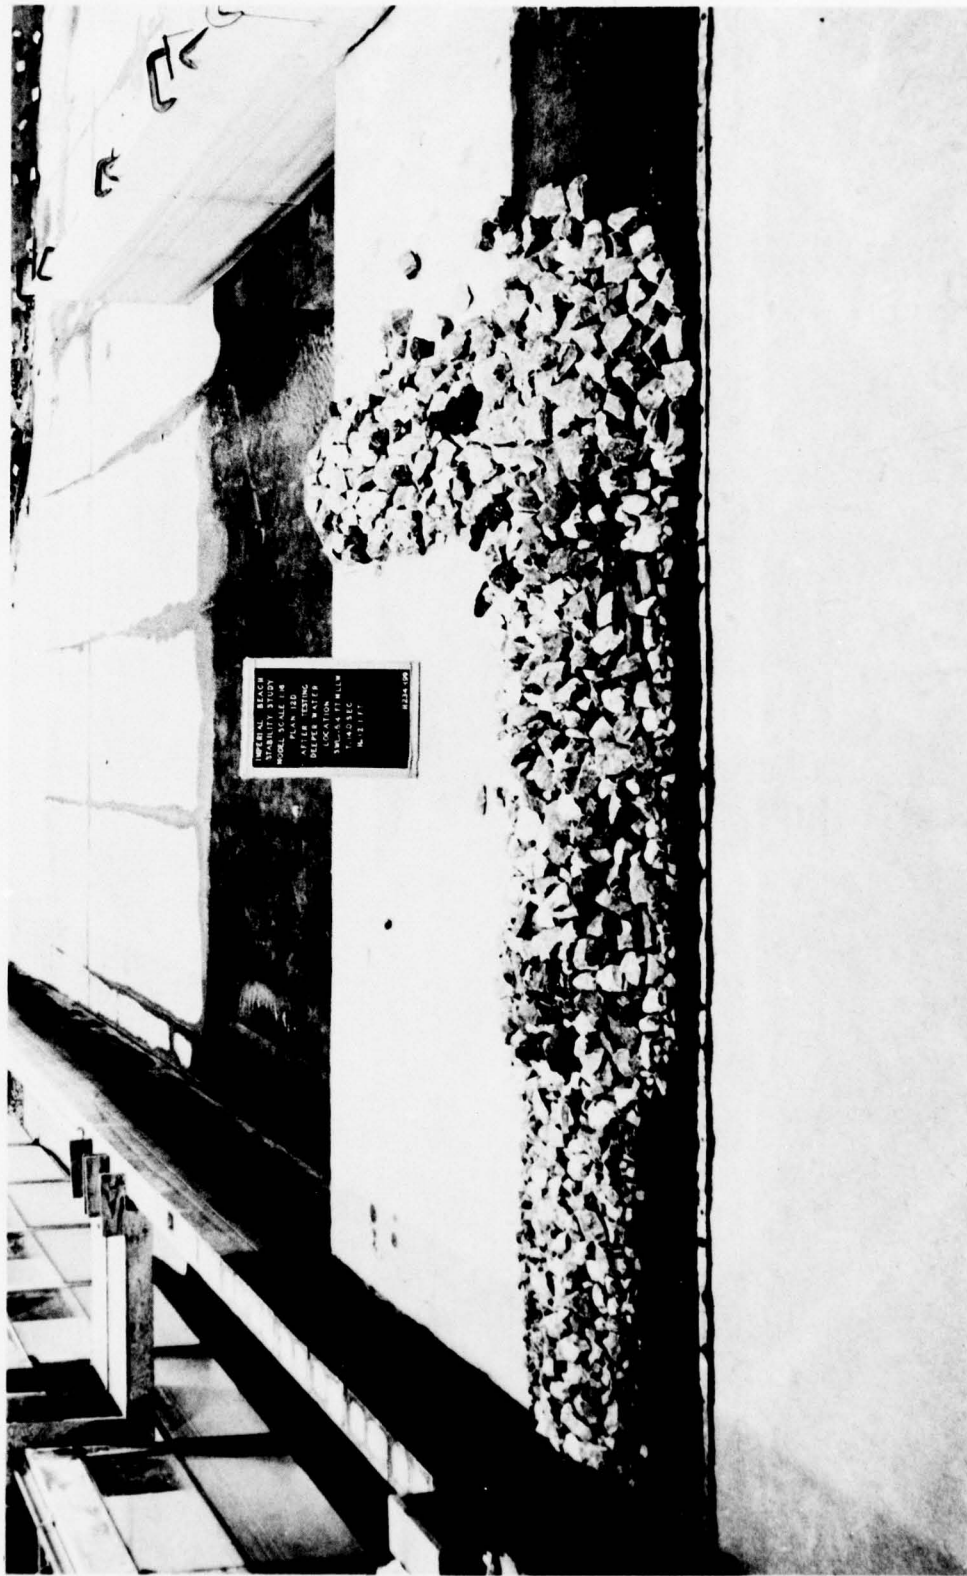
Photo 80. Sea-side view of Plan 12D in the deeper water location after 2.0 hr of 14.0-sec,
 12.1-ft waves at an swl of +5.4 ft mllw

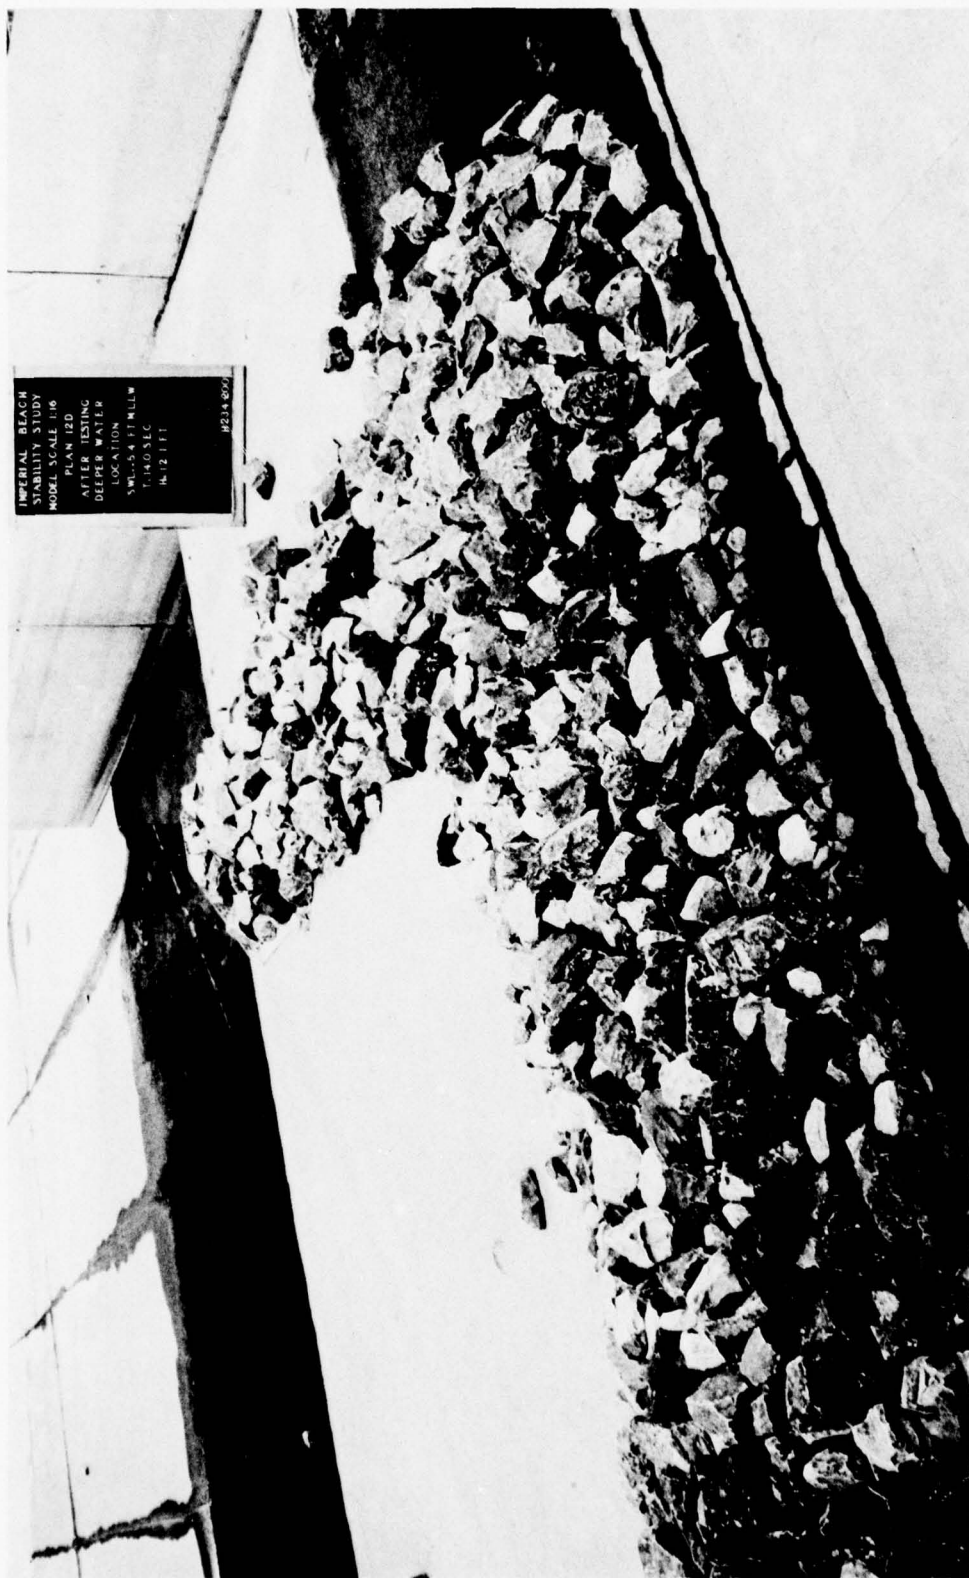
Photo 81. Sea-side view of high-sill section and 10.0-ft-high groin of Plan 12D in the deeper water location after 2.0 hr of 14.0-sec, 12.1-ft waves at an swl of +5.4 ft mllw

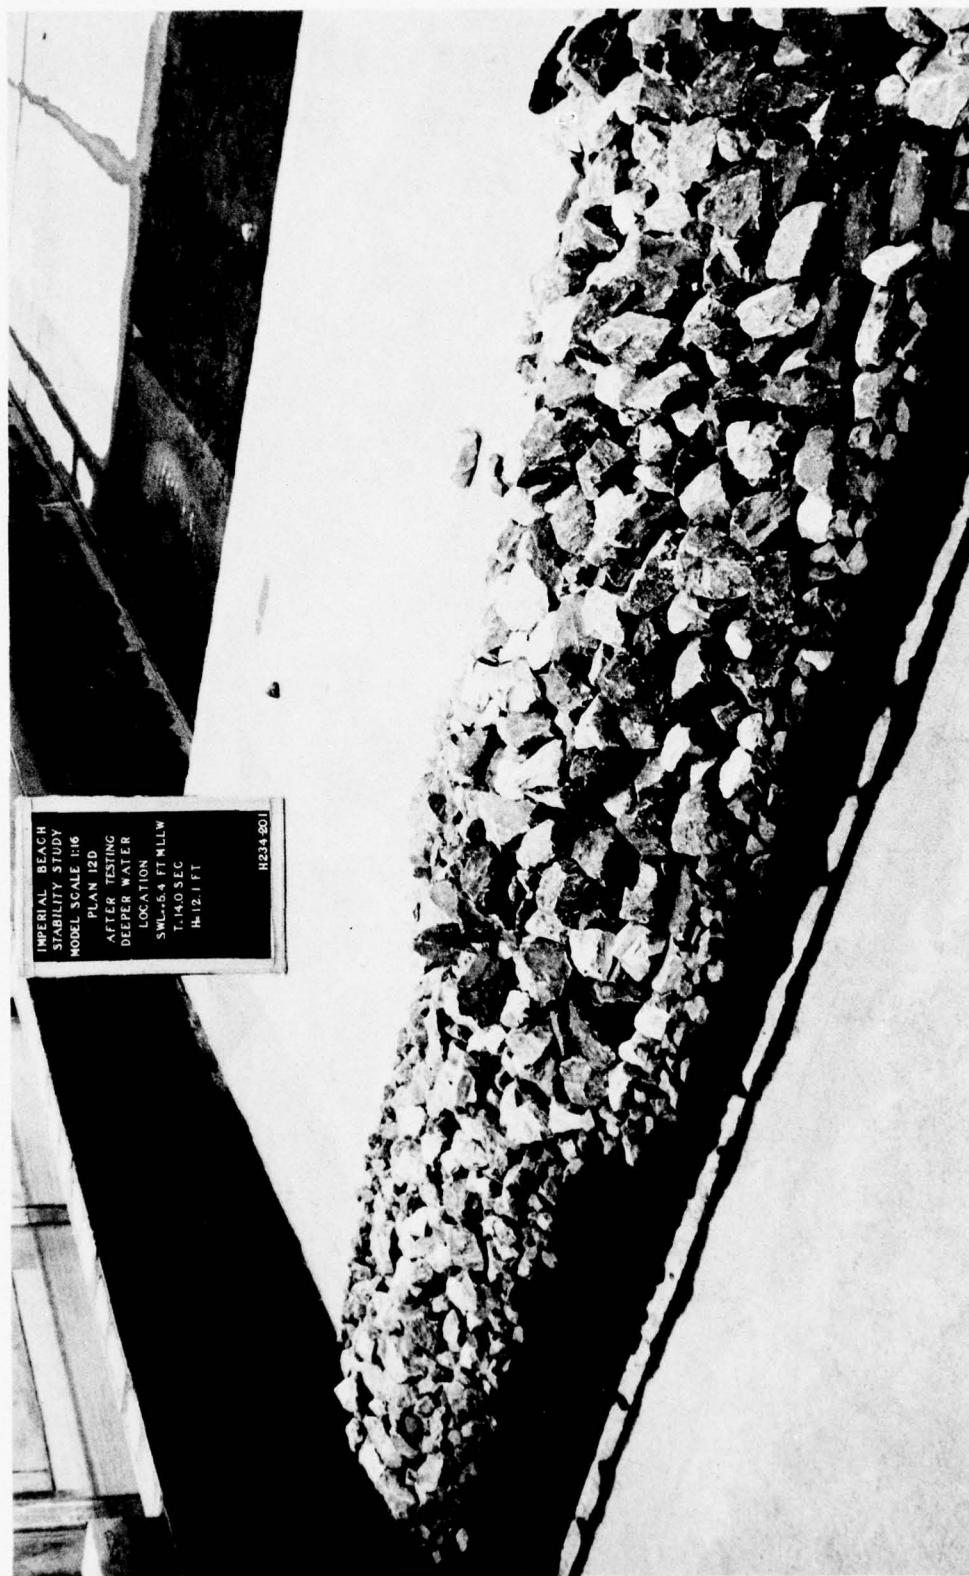
Photo 82. Sea-side view of low-sill section of Plan 12D in the deeper water location after 2.0 hr of 14.0-sec, 12.1-ft waves at an swl of +5.4 ft mllw

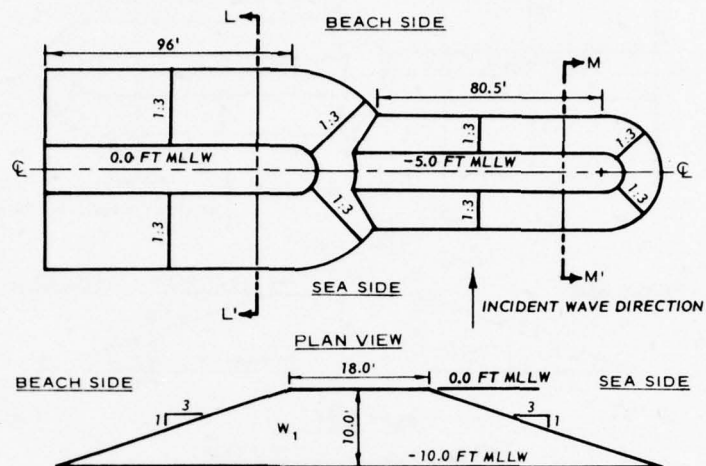
DEEPER WATER LOCATION
PLAN 7

NOTE: ASSUMES USE OF FILTER CLOTH UNDER ENTIRE BREAKWATER.

- (1) Plans 1-6 are inadequate designs due to high instability that resulted in extensive damage.
 - (2) Plans 7, 7A, 7B, and 7C used the same designs for the high-sill section and low-sill trunk but differing designs for the low-sill head. The designs for the high-sill section and low-sill trunk showed very minor damage. Only the Plan 7C design for the low-sill head proved adequate. Plan 7C would be a very acceptable alternating high- and low-sill design.

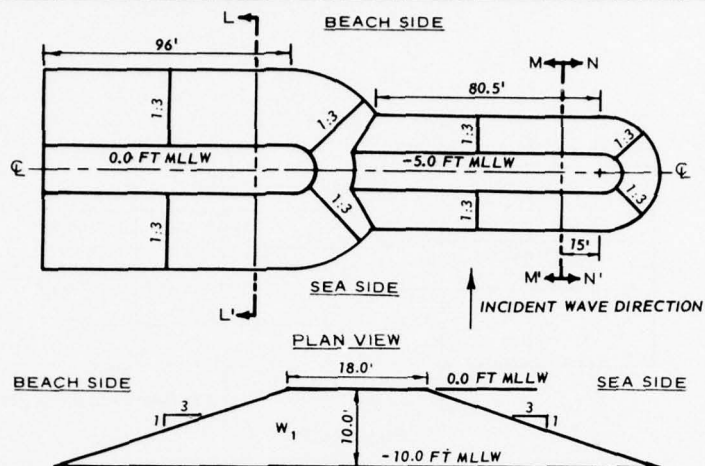
DEEPER WATER LOCATION
PLAN 7A

NOTE: ASSUMES USE OF FILTER CLOTH UNDER ENTIRE BREAKWATER.

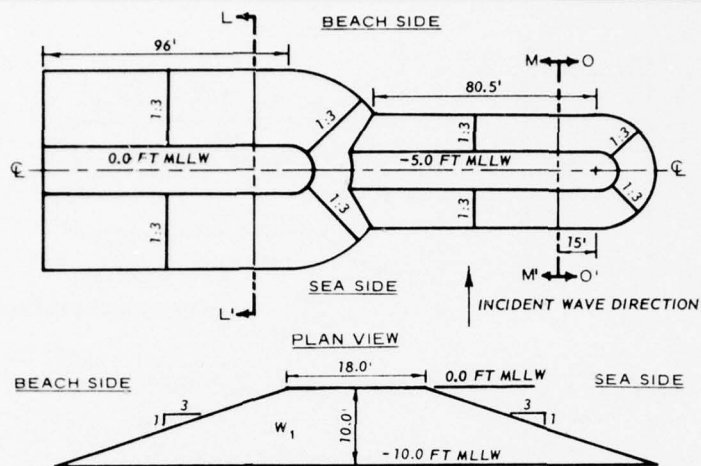
DEEPER WATER LOCATION
PLAN 7B

NOTE: ASSUMES USE OF FILTER CLOTH UNDER ENTIRE BREAKWATER.

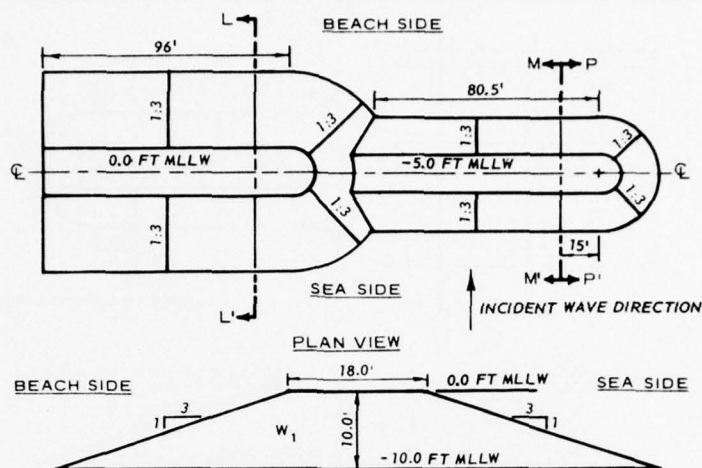
DEEPER WATER LOCATION
PLAN 7C

NOTE: ASSUMES USE OF FILTER CLOTH UNDER ENTIRE BREAKWATER.

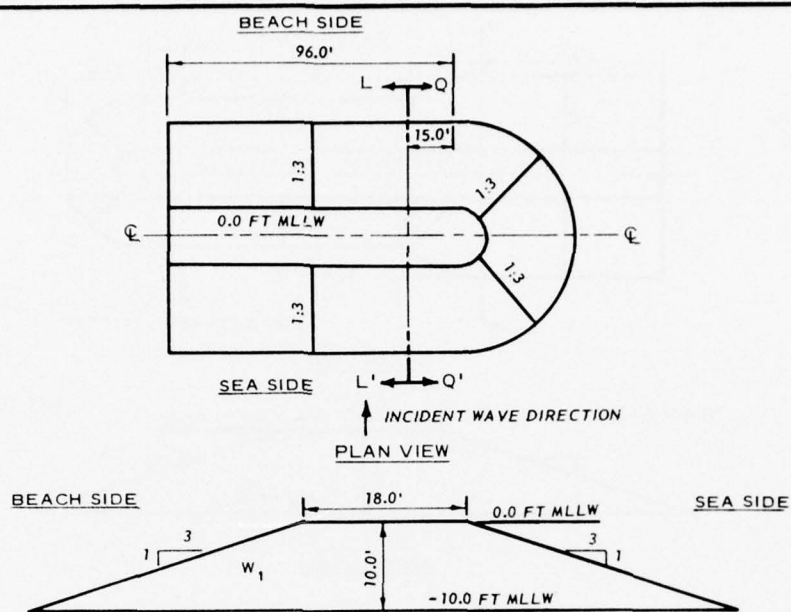
DEEPER WATER LOCATION
PLAN 8

NOTE: ASSUMES USE OF FILTER CLOTH
UNDER ENTIRE BREAKWATER.

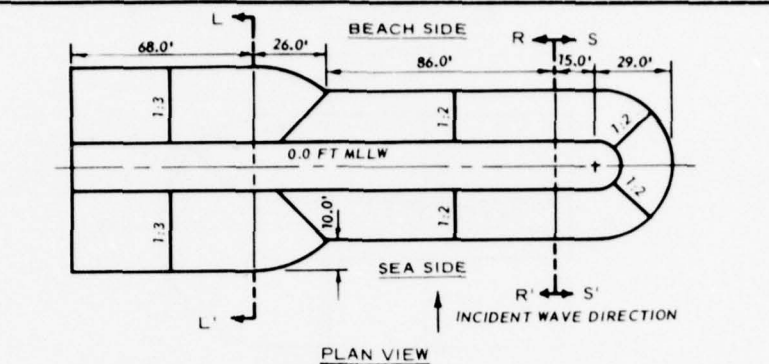
DEEPER WATER LOCATION
PLAN 9

MODEL	PROTOTYPE
W ₁ , GRADED % BY WEIGHT	W ₁ , GRADED % BY WEIGHT
100% ≤ 2.158-LB ROCK @ 165 PCF	100% ≤ 10,000-LB ROCK @ 165 PCF
50% < 1.295-LB ROCK @ 165 PCF	50% < 6,000-LB ROCK @ 165 PCF
25% < 0.648-LB ROCK @ 165 PCF	25% < 3,000-LB ROCK @ 165 PCF
12.5% < 0.432-LB ROCK @ 165 PCF	12.5% < 2,000-LB ROCK @ 165 PCF
5% < 0.001-LB ROCK @ 165 PCF	5% < 6-LB ROCK @ 165 PCF

NOTE: ASSUMES USE OF FILTER CLOTH UNDER ENTIRE BREAKWATER.

the high-sill section and low-sill trunk, respectively, were unstable with the 1V-on-2H side slopes. Extensive damage occurred for the low-sill head designs used in Plans 10 and 10A. Thus Plans 9, 10, and 10A are inadequate designs for the deeper water location.

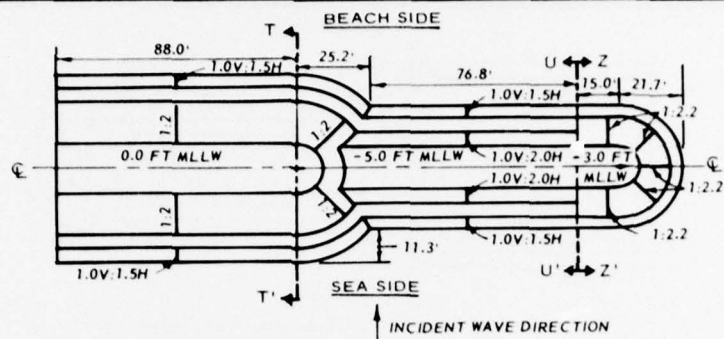
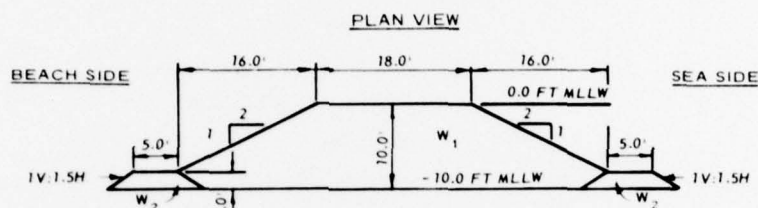
DEEPER WATER LOCATION
PLAN 10

SECTION T-T'

NOTE: ASSUMES USE OF FILTER CLOTH UNDER ENTIRE BREAKWATER.

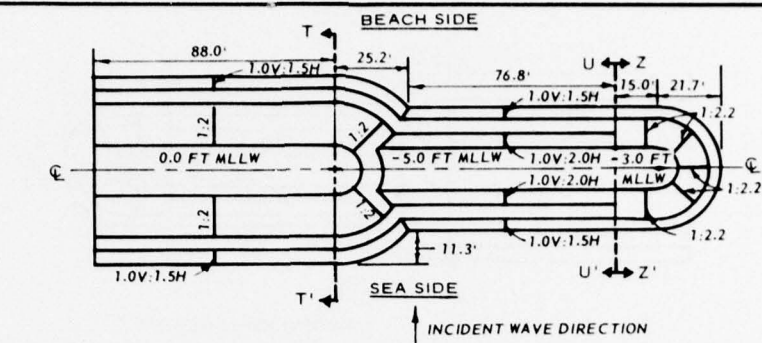
DEEPER WATER LOCATION
PLAN 10A

NOTE: ASSUMES USE OF FILTER CLOTH UNDER ENTIRE BREAKWATER.

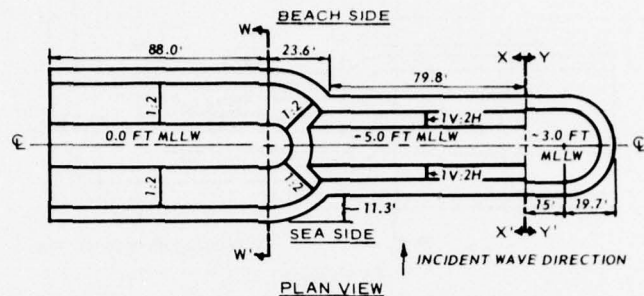
DEEPER WATER LOCATION
PLAN 11

MODEL	PROTOTYPE
W ₁ , GRADED % BY WEIGHT	W ₁ , GRADED % BY WEIGHT
100% ≤ 3.023-LB ROCK @ 165 PCF	100% ≤ 14,000-LB ROCK @ 165 PCF
50% < 2.158-LB ROCK @ 165 PCF	50% < 10,000-LB ROCK @ 165 PCF
25% < 1.295-LB ROCK @ 165 PCF	25% < 6,000-LB ROCK @ 165 PCF
12.5% < 0.648-LB ROCK @ 165 PCF	12.5% < 3,000-LB ROCK @ 165 PCF
6.25% < 0.432-LB ROCK @ 165 PCF	6.25% < 2,000-LB ROCK @ 165 PCF
2.5% < 0.001-LB ROCK @ 165 PCF	2.5% < 6-LB ROCK @ 165 PCF
W ₂ = 0.22-LB ROCK @ 165 PCF	W ₂ = 1,000-LB ROCK @ 165 PCF

NOTE: ASSUMES USE OF FILTER CLOTH UNDER ENTIRE BREAKWATER.

- (5) Due to the nature of the 7.0- and 5.0-ton graded armor stone, some spot damage occurred on the high- and low-sill trunks and the transition between them in Plans 11 and 12 when exposed to the design conditions of 14.0-sec, 12.1-ft waves at an swl of +5.4 ft mllw. This damage is mainly due to displacement of some of the lighter stone. This results in some reduction (on the average, approximately 1 ft with extremes up to 2 ft) of the high- and low-sill section crown elevation at various points. Since the entire breakwater consists of alternating high- and low-sill sections, which will be totally submerged for all water levels above 0.0 ft mllw swl, this minor lowering of the high-sill crown elevation at various locations should not alter the functional integrity of the structure (i.e., minimize the wave energy and contain the sand in the nourished beach area behind the breakwater). Therefore, even though the high- and low-sill trunks and the transition between them in Plans 11 and 12 do not meet the no-damage criterion of minor stone movement that is usually used for breakwaters which are designed for the safety of life and property, they should function adequately for this particular application.

- (6) The low-sill head tested in Plan 11 showed very little damage when subjected to design conditions; thus one layer of 7.0-ton armor stone on a slope of approximately 1V on 2.5H is an adequate low-sill head design.

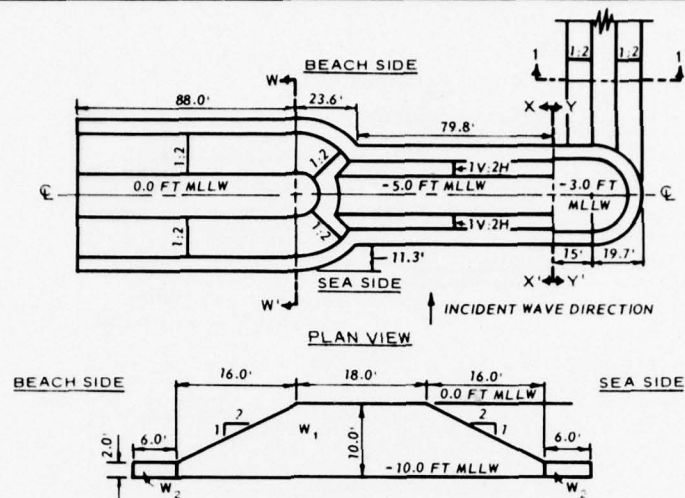
DEEPER WATER LOCATION
PLAN 11A

NOTE: ASSUMES USE OF FILTER CLOTH UNDER ENTIRE BREAKWATER.

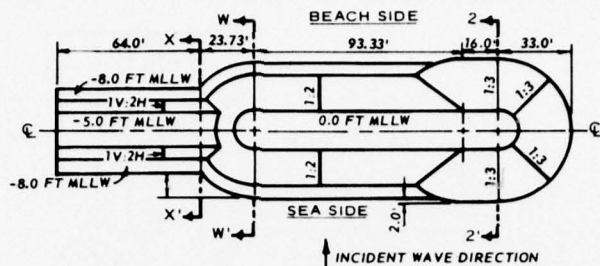
DEEPER WATER LOCATION
PLAN 12

NOTE: ASSUMES USE OF FILTER CLOTH UNDER ENTIRE BREAKWATER.

- (7) The Plan 12 high-sill head sustained moderate, but reparable, damage when exposed to the 14.0-sec, 12.1-ft waves at an swl of +5.4 ft mllw. Like the damage that resulted on the high-sill trunk of this plan, this moderate damage does not appreciably alter the design function of the high-sill head; thus one layer of 7.0-ton armor stone on a slope of 1V on 3H is an adequate high-sill head design.

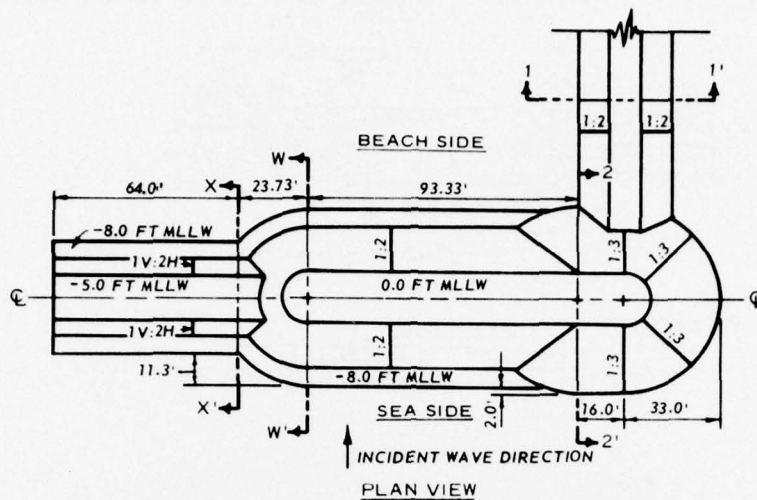
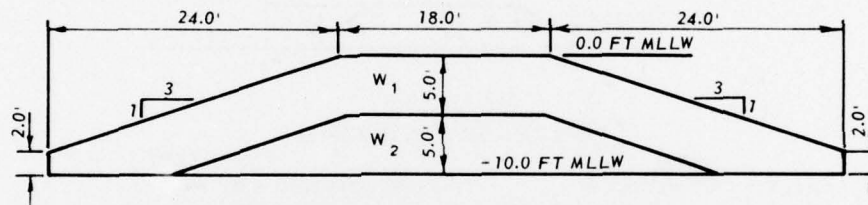
DEEPER WATER LOCATION
PLAN 12A

NOTE: ASSUMES USE OF FILTER CLOTH UNDER ENTIRE BREAKWATER.

29. Plan 12A (Plate 18 and Photo 66) consisted of rebuilding the high-sill head and adding a 5-ft-high, beach-connected groin to Plan 12. The groin was constructed with 1V-on-2H slopes using 5.0-ton graded armor stone and connected at a 90° angle to the beach side of the high-sill head. In order to observe the effect of extended wave attack on the high-sill and low-sill trunk, these sections of the Plan 12 breakwater were not rebuilt before testing was initiated on Plan 12A. After 2.0 hr of attack by 14.0-sec, 12.1-ft waves at an swl of +5.4 ft mllw caused minor damage on the high-sill head and groin. Little change occurred to those portions of the structure which were not rebuilt after testing Plan 12 (Photos 67-69). The breakwater was then exposed to 1.0 hr of 14.0-sec, 8.3-ft waves at an swl of 0.0 ft mllw to check for any possible stability problems on the 5-ft-high groin when exposed to this low-water wave attack. No instability was observed on the groin and the remainder of the breakwater showed very little change.

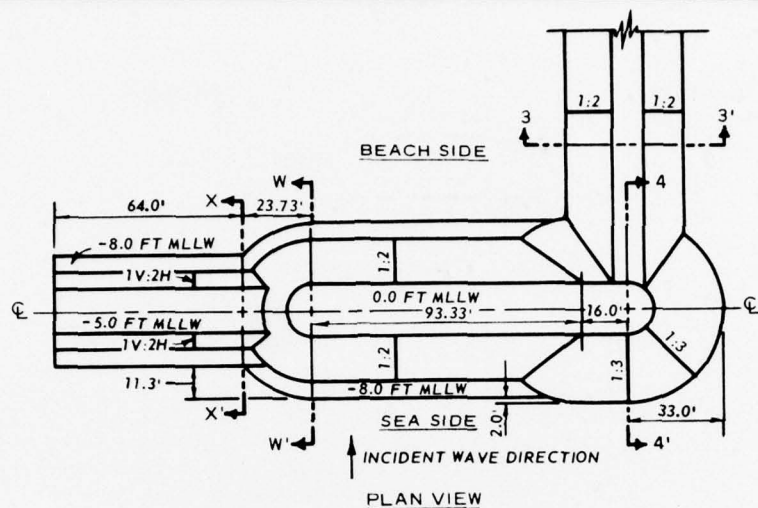
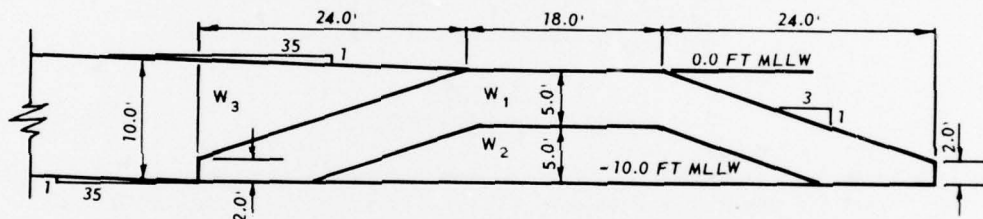
DEEPER WATER LOCATION
PLAN 12B

NOTE: ASSUMES USE OF FILTER CLOTH UNDER ENTIRE BREAKWATER.

30. Plan 12B (Plate 19 and Photo 70) consisted of the addition of a 10-ft-high, 5.0-ton graded armor stone, beach-connected groin and rebuilding of the high-sill head on Plan 12A. The remainder of the breakwater, the high- and low-sill trunks, was once again not rebuilt in order to observe the results of extended wave attack. After 2.0 hr of exposure to 14.0-sec, 12.1-ft waves at an swl of +5.4 ft mllw, the intersection between the high-sill head and groin showed significant damage and the remainder of the breakwater showed minor to moderate damage (Photos 71-73).

- (9) The Plan 12B 10-ft-high groin proved to be unstable and thus inadequate at the intersection of the high-sill head and groin.
- (10) Capping the first 40 ft of the 10-ft-high, 5.0-ton graded armor stone groin adjacent to the high-sill head with one layer of 7.0-ton armor stone (Plan 12C) resulted in a stable connecting area between the high-sill head and groin.
- (11) Plan 12D sustained moderate damage in the region connecting the 10-ft-high groin and the high-sill head when exposed to design conditions. The Plan 12C design for this area is, therefore, recommended over the Plan 12D design; but Plan 12D could be used if it is kept in mind that it would require more maintenance than the 7.0-ton capstone used in Plan 12C.

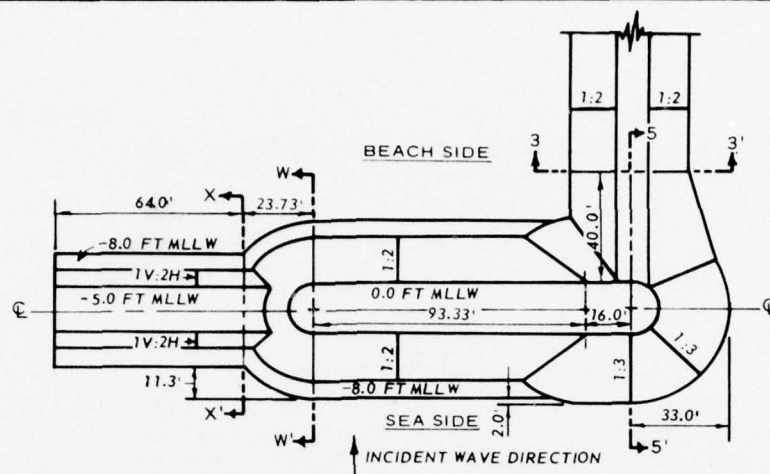
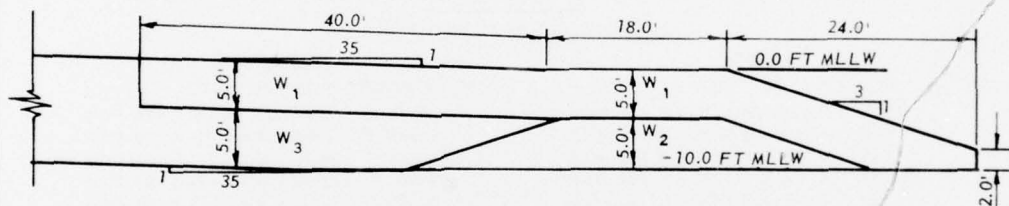
DEEPER WATER LOCATION
PLAN 12C

NOTE: ASSUMES USE OF FILTER CLOTH UNDER ENTIRE BREAKWATER.

31. Plan 12C (Plate 20 and Photos 74 and 75) was identical with Plan 12B except that the first 40 ft of the 10-ft-high groin adjacent to the high-sill head was capped with one layer of 7.0-ton armor stone. Like Plans 12A and 12B, the high-sill head was rebuilt, but the remainder of the breakwater was not. The breakwater was then exposed to 2.0 hr of 14.0-sec, 12.1-ft waves at an swl of +5.4 ft mllw. At the conclusion of the test all damage had stabilized. Minor damage had occurred on the high-sill head and groin. The high- and low-sill trunk sections had been exposed for a total of 10.0 hr to 14.0-sec, 12.1-ft waves at an swl
